Re: Grant Project Number 455551-76
Clean Michigan Initiative
Restoration of DeTour reef Light

**CLEAN MICHIGAN INITIATIVE
WATERFRONT REDEVELOPMENT GRANT FOR MICHIGAN LIGHTHOUSES**

The Restoration of the DeTour Reef Light

Department of Environmental Quality Site Reclamation Program
November 21, 2004

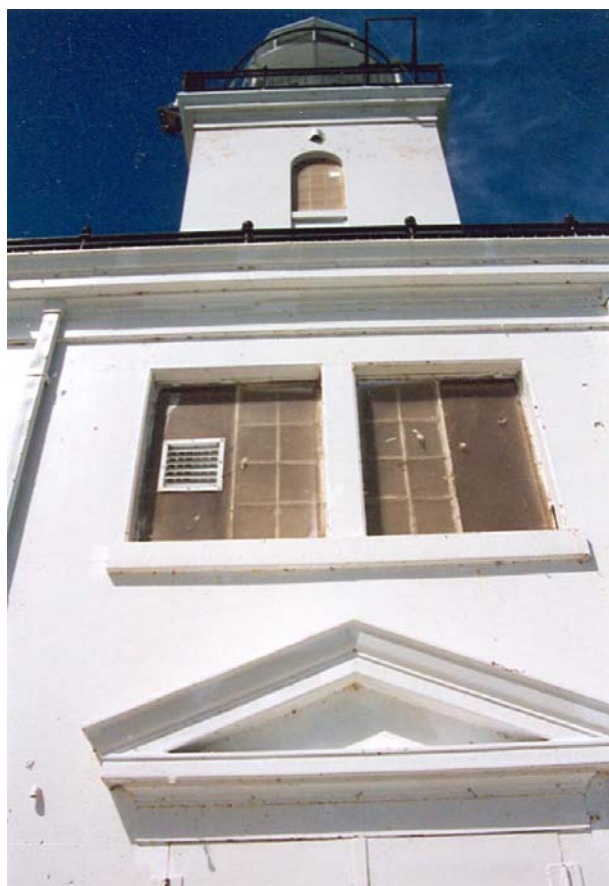
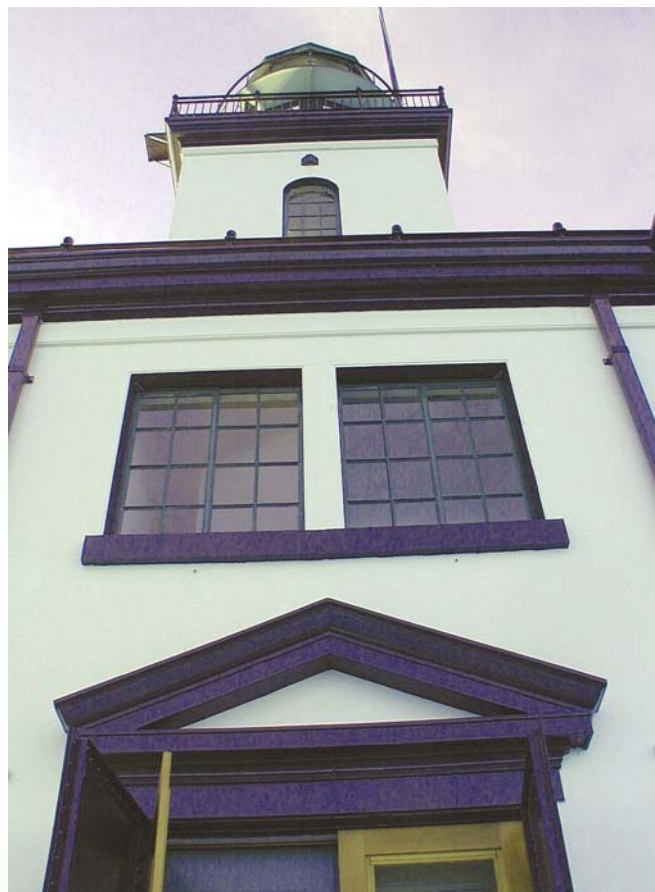
View of Pediment above Front Door and of Upper Tower Levels

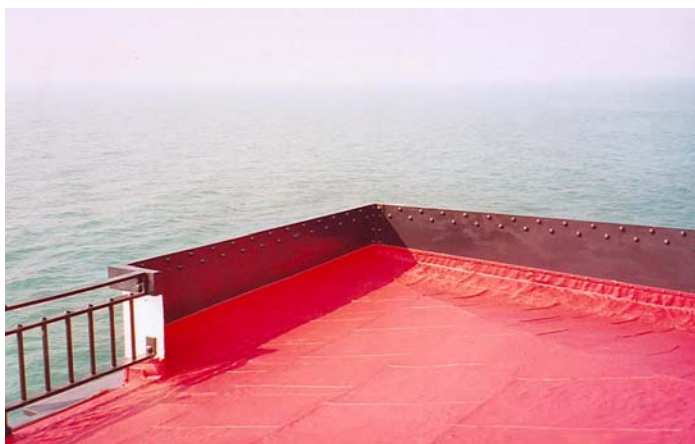
Northeast Corner of Tower Roof

9. Installed new flagpole at lantern deck level.
10. Installed new steel pipe smokestack at lantern deck level and reconnected existing stack.
11. Removed membrane roof and installed new copper roof at tower level.

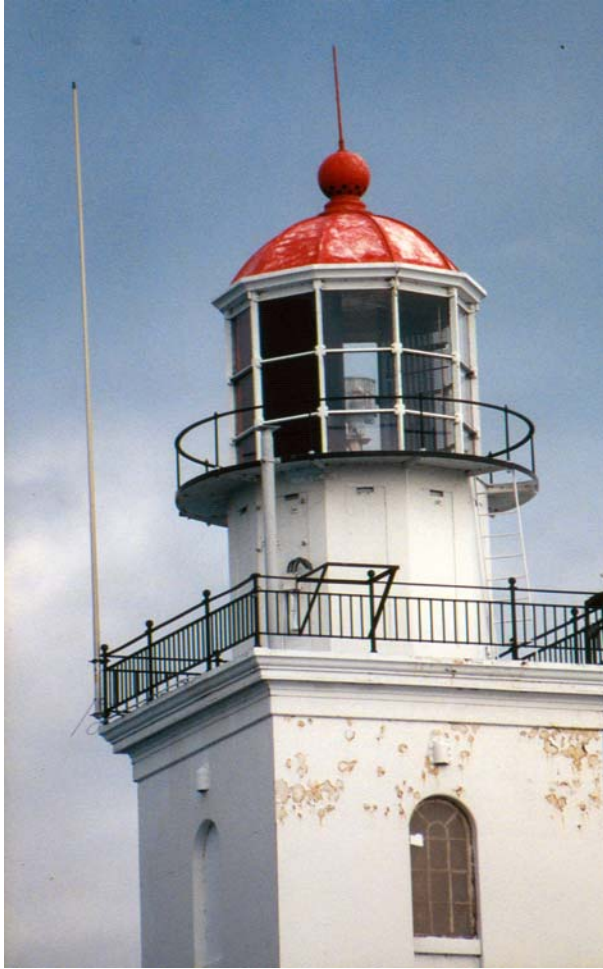
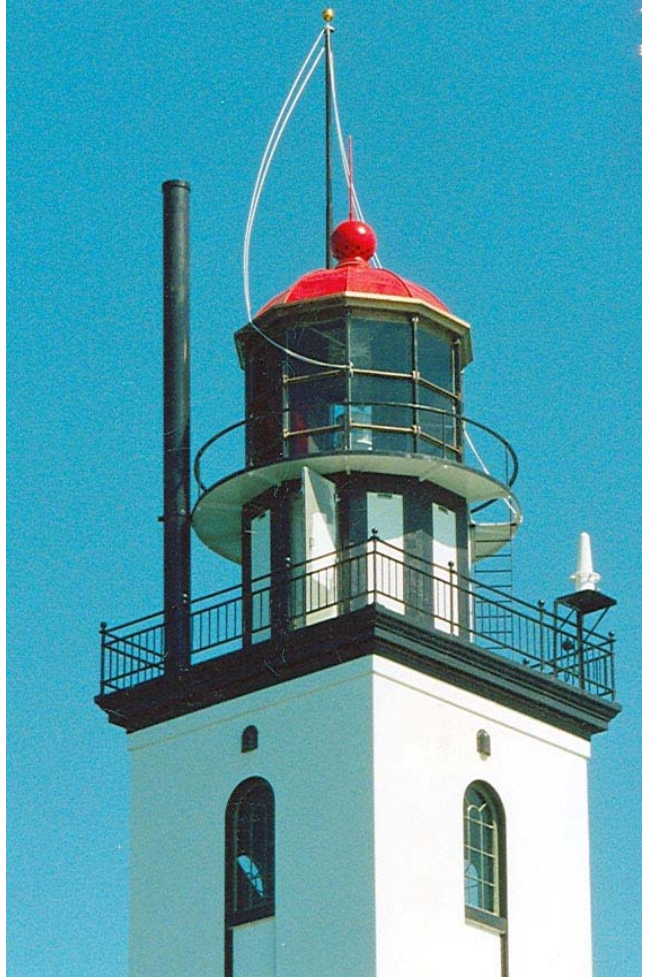
Upper Tower Including View of Watch Room and Lantern Room

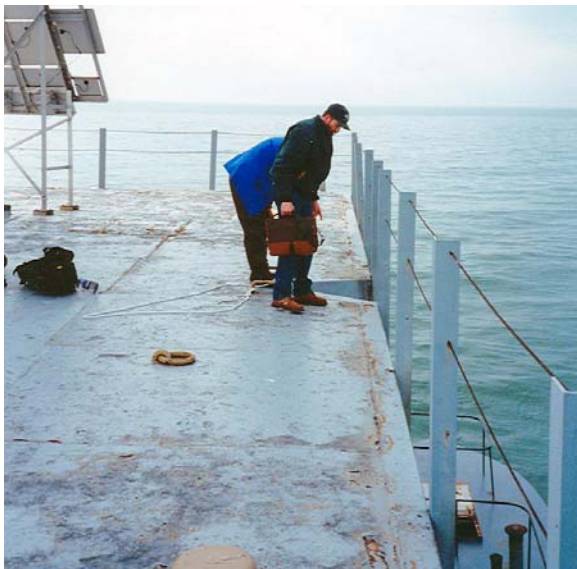
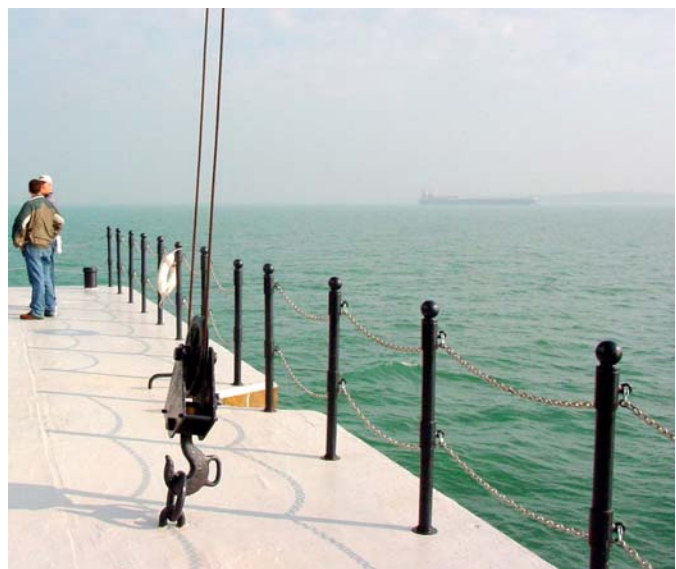
Guard Rail around the Periphery of the Pier Deck

1. Removed steel plate located on pier deck level and bent plates at deck edge and building base.
2. Removed steel angle and cable guardrail located on pier deck level.
3. Cleaned concrete surface of pier deck.
4. Patched and repaired damaged vertical concrete surfaces of crib structure.
5. Installed new guardrail at pier deck level.
6. Mechanically cleaned, refinished and restored to operational condition all steel plate window and door shutters.
7. Mechanically cleaned, refinished and restored with new coatings all steel plate wall surfaces, decorative metal trim, solid plate railings and pipe railings.
8. Mechanically cleaned and refinished steel ladders and replaced damaged ladder components below pier deck.

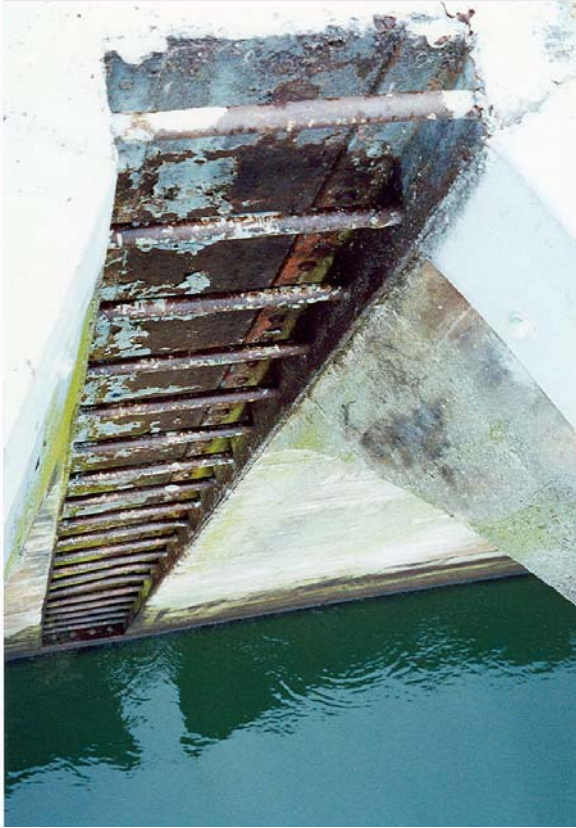
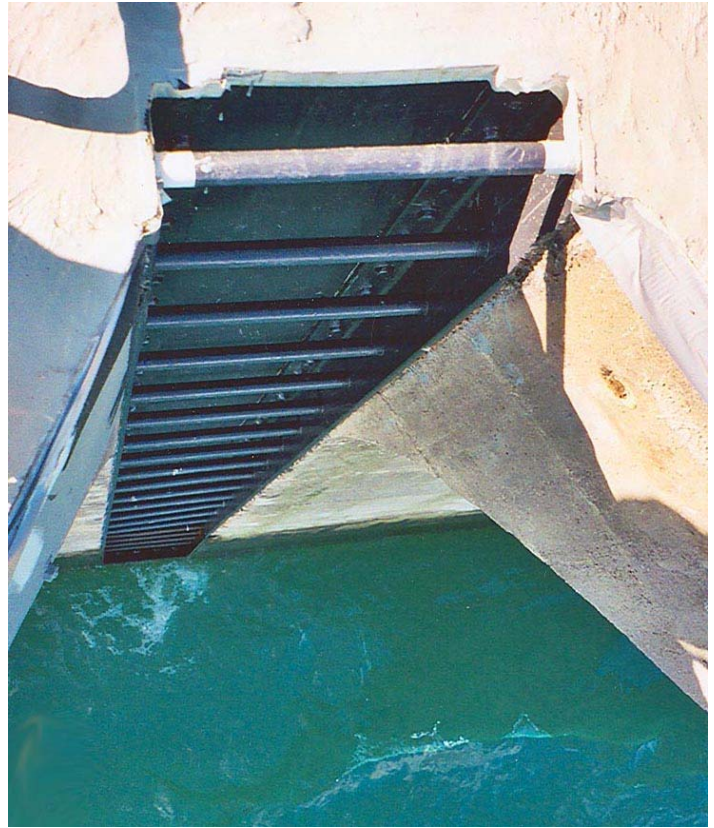
One of the Four Ladders that Provide Access to the Pier Deck from a Boat

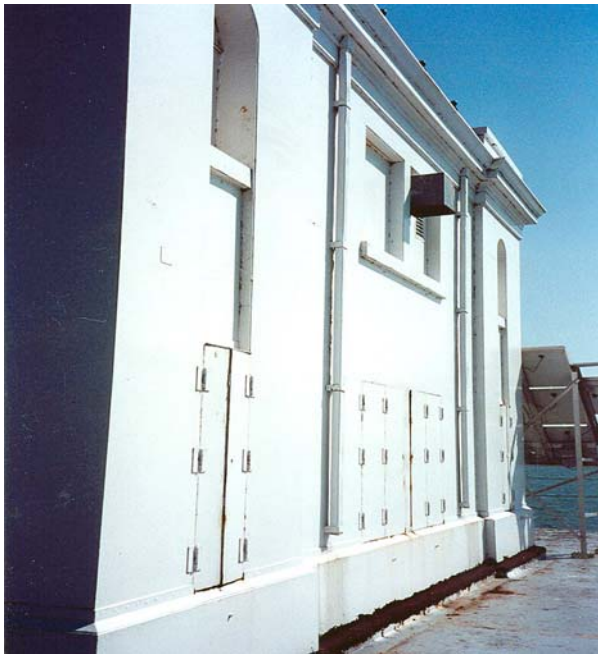
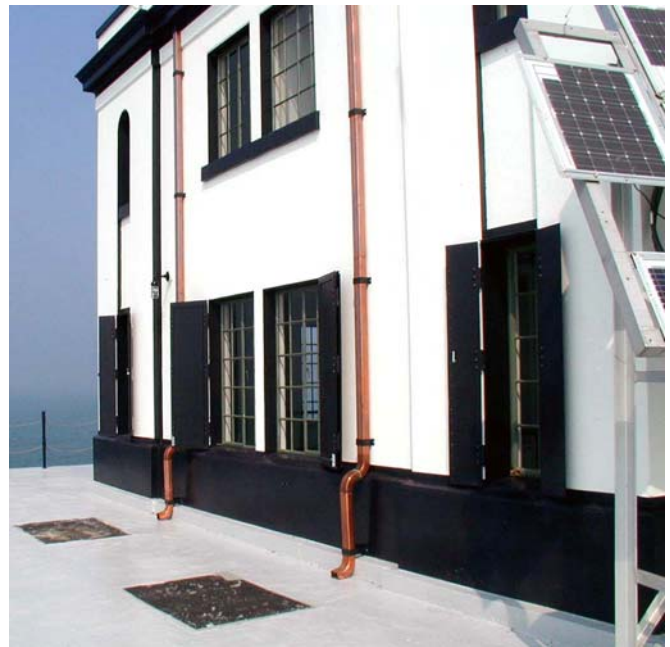
West Wall of Lower Tower

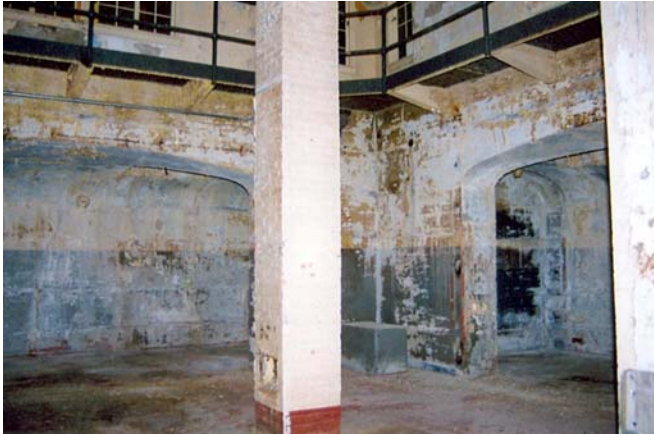
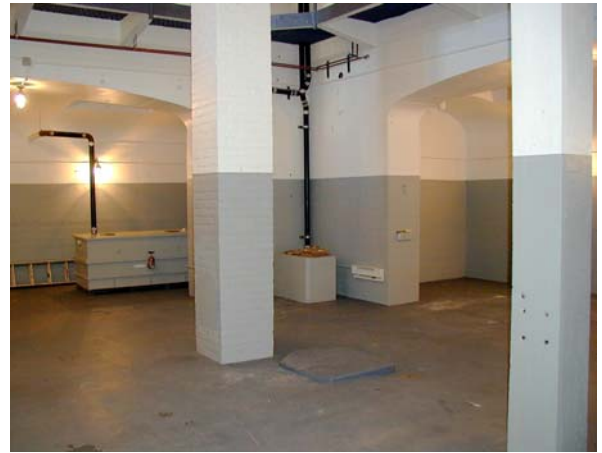
Machinery Room Level Showing Area where New Marine Sanitation System is Installed

1. Demolition/disposal of post 1931 partition walls.
2. Concrete work/repair throughout, especially in machinery room.
3. New partitions installed to replicate 1931 floor plan.
4. Plaster restoration performed throughout the interior.
5. Painting/finishing throughout matching original 1931 color scheme.
6. Floor coverings replaced to match original.
7. New replica doors and hardware installed.
8. Casework/cabinetry/metal trim replaced or repaired.
9. New electric hoist installed in gallery room.
10. Plumbing including fixtures, piping and water treatment system installed.
11. Marine sanitation device installed.

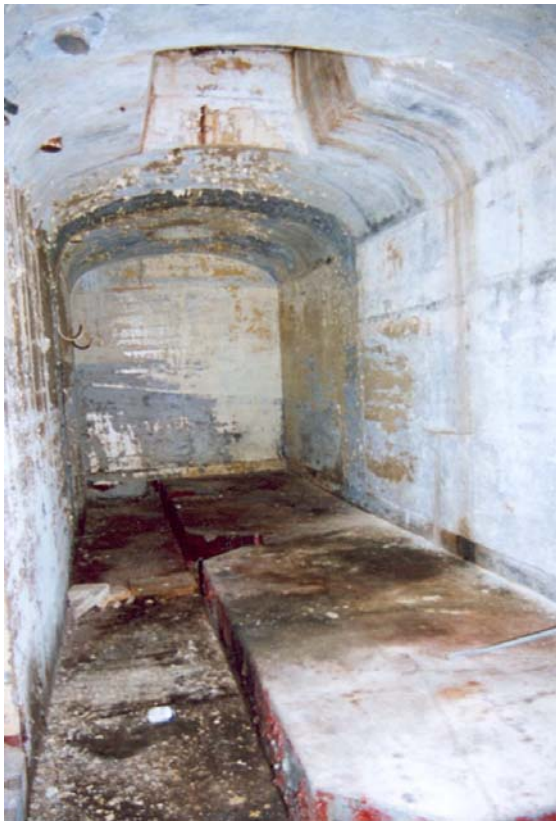
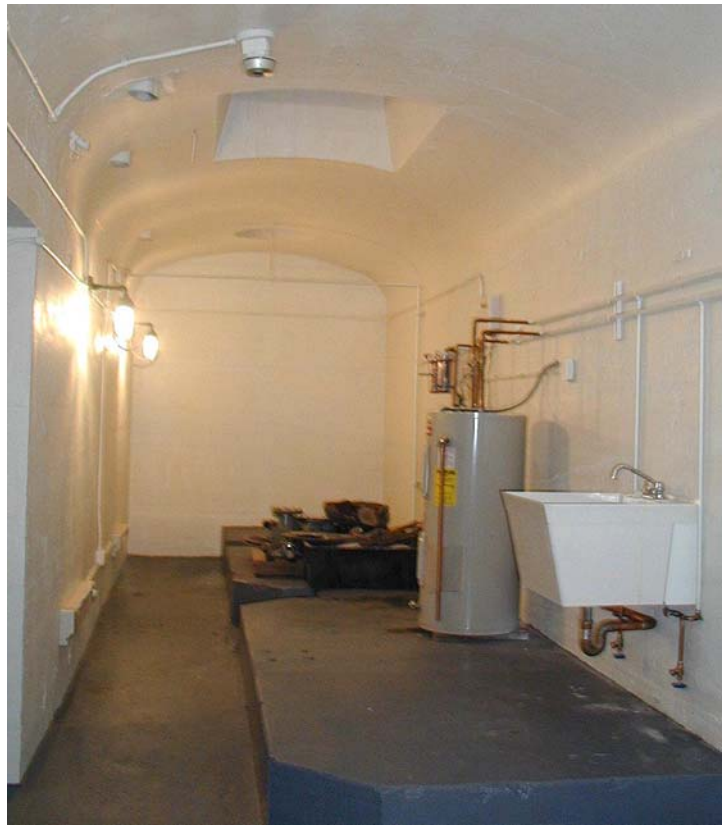
Former Fuel Storage Area in Machinery Room With New Water Treatment System Installed

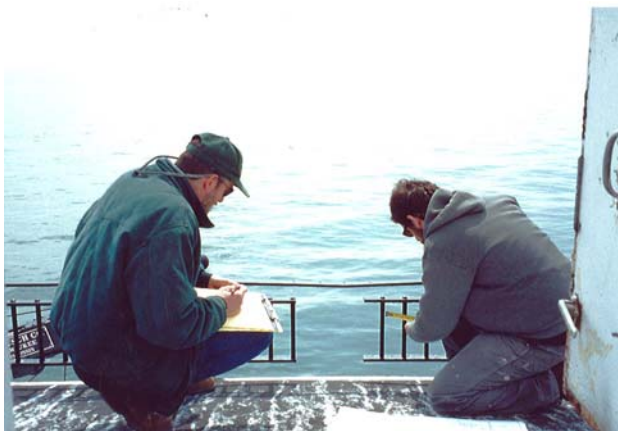
UPEA Engineers Examine Broken Railing

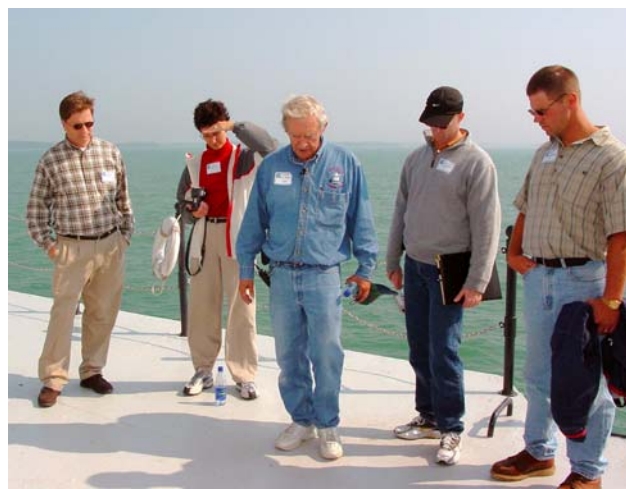
Examining the Pier Deck Surface Coating

18. Mechanically cleaned and refinished copper dome and pinnacle.
19. New diaphones installed.
20. New material transport cage constructed.
21. Patched and repaired damaged horizontal concrete surfaces of pier deck (1,620 s.f.) and applied new deck coating to entire pier deck surface.
