Re: Grant Project Number 455551-76
Clean Michigan Initiative
Restoration of DeTour reef Light

**CLEAN MICHIGAN INITIATIVE
WATERFRONT REDEVELOPMENT GRANT FOR MICHIGAN LIGHTHOUSES**

The Restoration of the DeTour Reef Light

Department of Environmental Quality Site Reclamation Program
November 21, 2004

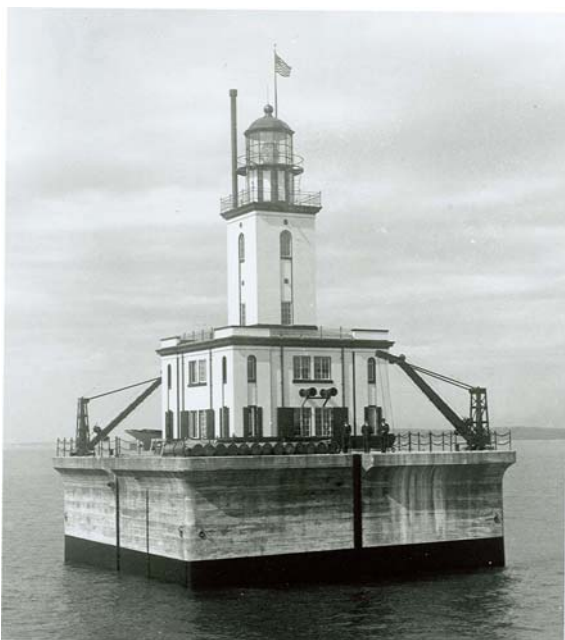
DeTour Reef Light (DRL) As Built in 1931

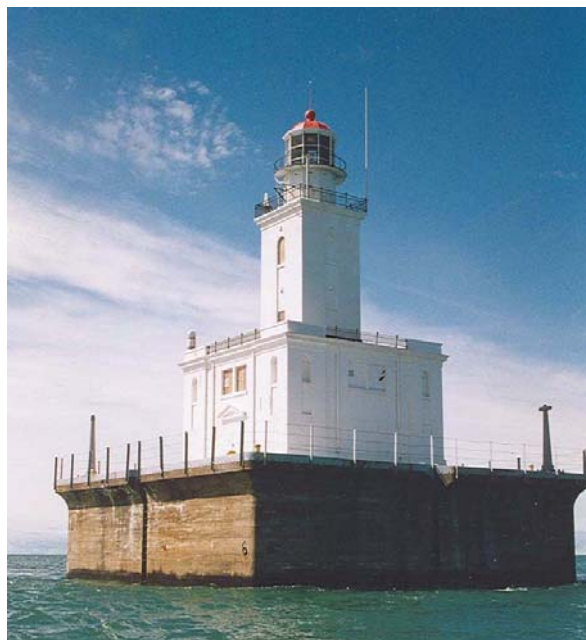
USCG Declares DRL as Excess Property in 1997

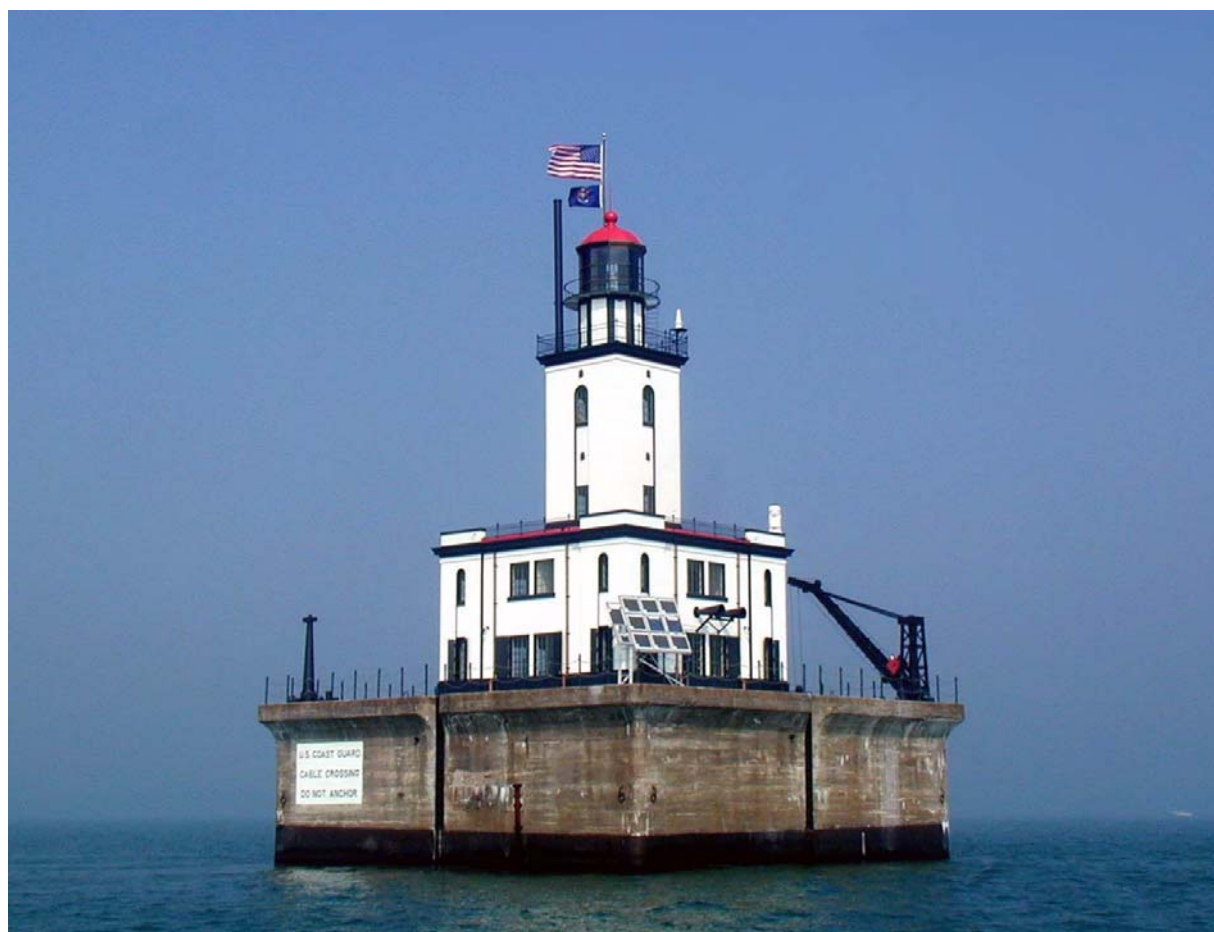
DRL as Restored, September 4, 2004

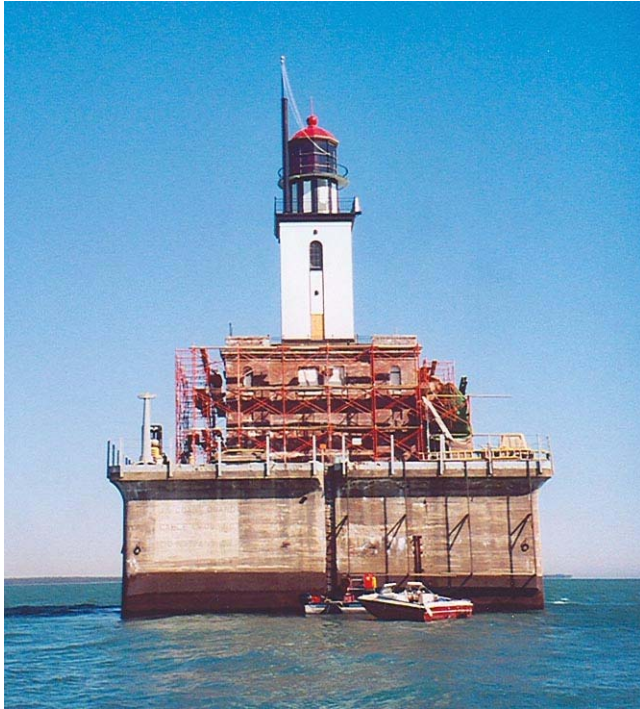
Lower Tower being Prepared for Painting

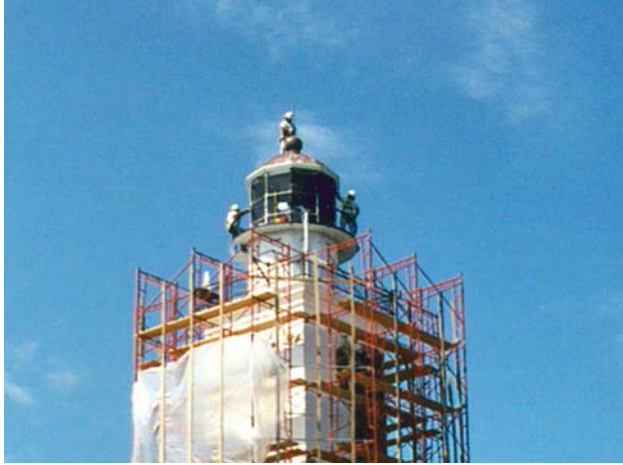
Restoring the Lantern Dome

18. Mechanically cleaned and refinished copper dome and pinnacle.
19. New diaphones installed.
20. New material transport cage constructed.
21. Patched and repaired damaged horizontal concrete surfaces of pier deck (1,620 s.f.) and applied new deck coating to entire pier deck surface.

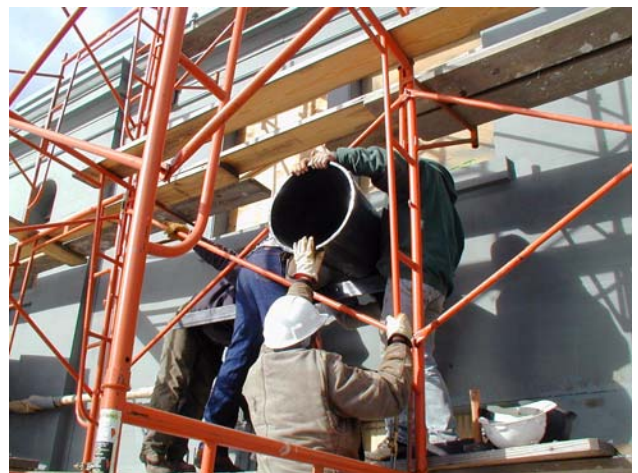
Installing One of the Fog Horns

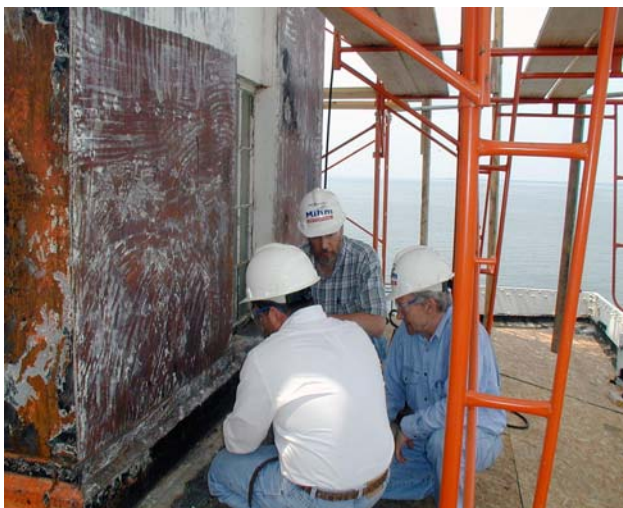
Discussing How to Repair the Roof
